**CRASH INJURY INVESTIGATION**

**HU-1A BELL IROQUOIS HELICOPTER ACCIDENT**

Fort Carson, Colorado • 7 May 1962

Report of Crash Injury Investigation  
AvCIR 62-14

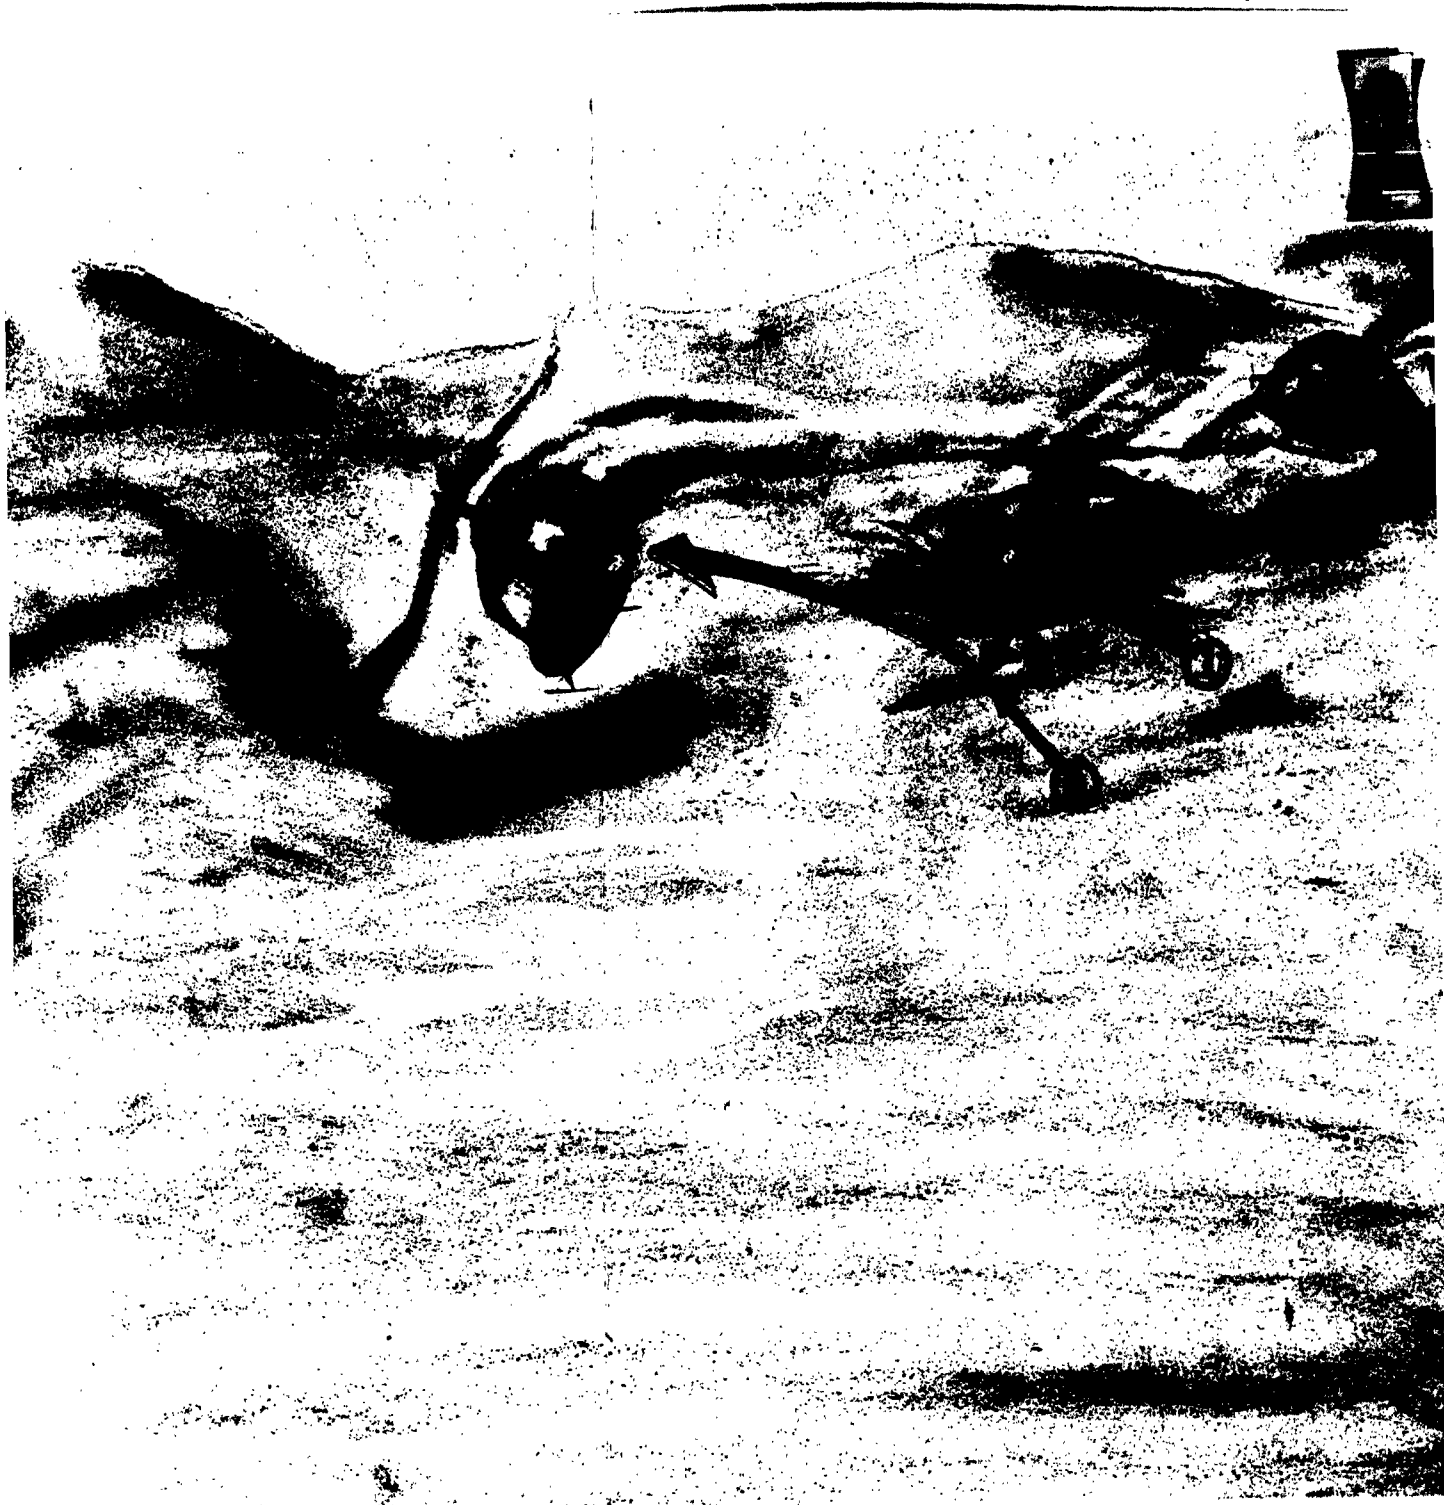
Initial contact with the ground occurred on the tail skid, followed by contact of the tail boom. The indicated air speed at this time was 60 knots. The boom failed immediately forward of the tail rotor pylon and was bent upward and forward. As the main fuselage continued to descend, the right skid struck the ground. At this point, one of the main rotor blades severed the tail rotor drive shaft above the horizontal stabilizer. The helicopter then rebounded into the air and struck the ground a second time with approximately a 30-degree left roll. The main rotor blade again struck the tail boom, severing it approximately 6 inches forward of the horizontal stabilizer. Following this impact, the helicopter again became airborne, turned approximately 90 degrees to the left about its vertical axis, continuing in its original line of flight, and struck the ground a third time. From this point, the remaining fuselage rolled one and one-half times about its longitudinal axis in contact with the ground, coming to rest inverted. During the roll, various components were torn free and dispersed throughout the area. Figures 1 and 2 show the manner in which the helicopter came to rest; Figure 3 shows the sequence of action during the crash.

**Figure 3. Kinematics of Crash Sequence.**  
**① shows impact at right skid. ② shows impact at left skid.**

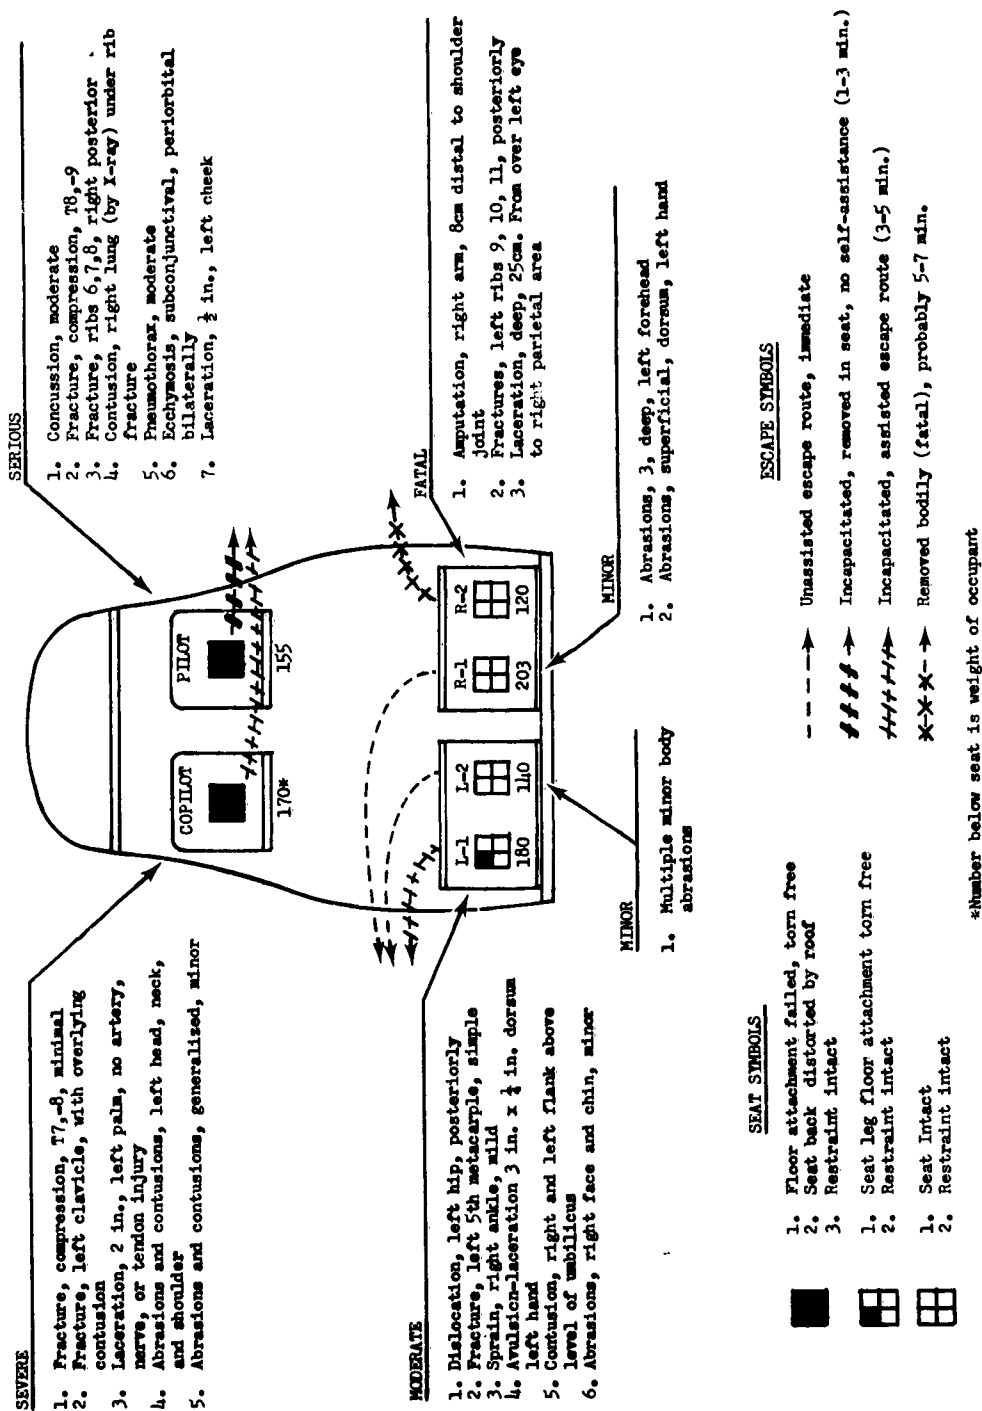
Figure 12. Escape Transpositions, Seat Damage, and Injury.

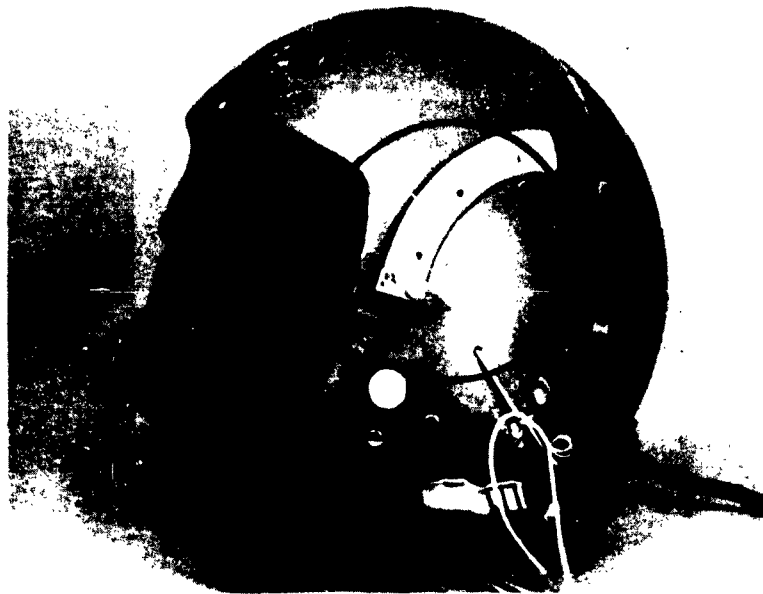
Possibly the most significant damage to the helmet is shown in Figure 15. The shell immediately underlying the left visor keeper is fractured in two places. The reason that these cracks are significant is that the force of the blows to the helmet were great enough to cause this cracking even before any deformation of the energy-absorbing liner occurred. Thus, the shell began to break down and would have failed prematurely, which would have allowed local transmission of forces to the pilot's head under the keeper.

Figure 15. View of Damage Sustained by APH-5 Helmet
